Manhole Inspection Summary

Manhole # S29S__017MH

Insp Date: **10/31/08 8:56 AM**

Location Address: **1900 Bayard St**

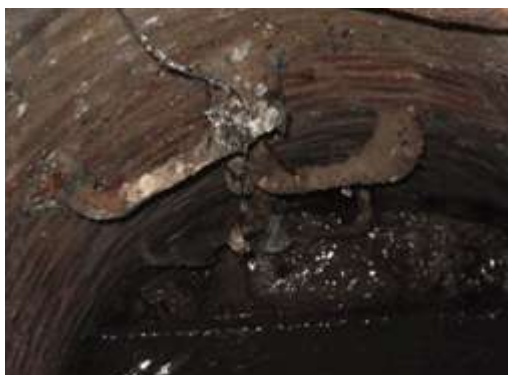
Defect 3

Condition: ☐ Sound ☐ Cracked ☐ Root Intrusion ☒ **Deteriorated** ☐ Leaks ☒ **Debris**

☒ **Evidence Of Surcharge** Depth: **4** (ft.) ☐ Active Surcharge Present

signs of surcharge, bench debris, bench appears deteriorated

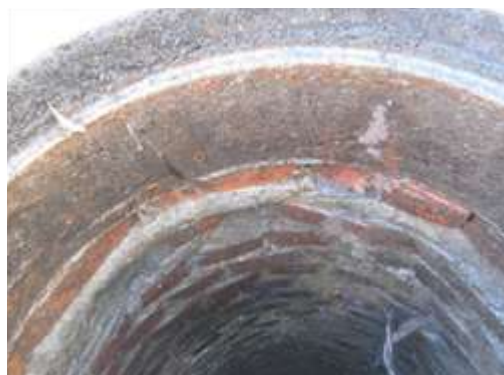
Defect 2

☒ **Leaks**

frame leaks

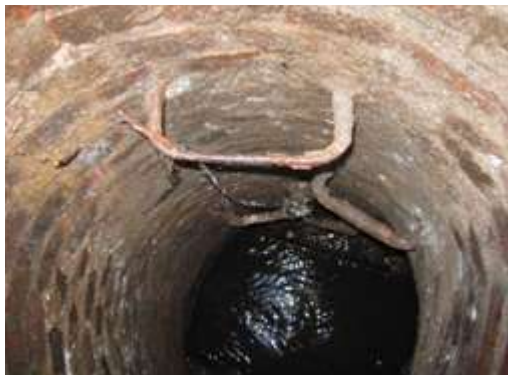
Defect 1

Count: **6** Missing: **0** ☒ **Corroded**

corroded rungs
